Case Study

Hammersmith Hospital

Hospital kitchen finds greener way to treat grease with ACO.

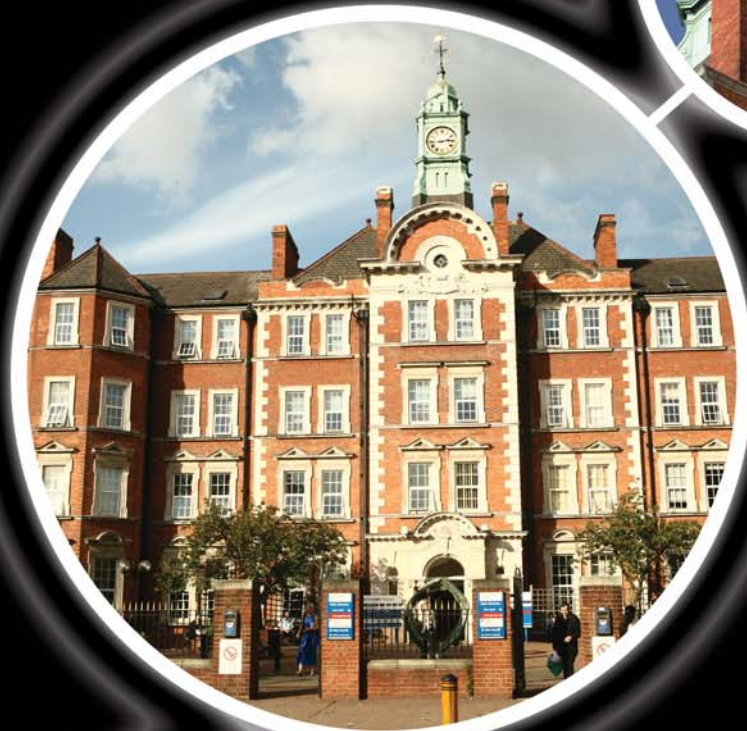
Determination of separator size through BS EN 1825 methodology. Enabling street level disposal connection with optional on-board disposal pump.

The system that ACO installed in the basement of the hospital consisted of a Hydrojet grease separator with disposal pump for easy and convenient tanker waste collection at street level. The Hydrojet was dismantled into three components to enable efficient installation in the basement where access was restricted. Constructed from corrosion resistant HDPE rather than mild steel, the solution has eliminated problems of smells and leakages. Unlike the previous system, which required regular dosing of biological activator, the Hydrojet works on natural buoyancy processes to separate solids, fats, oils, and grease from wastewater. The separated water is then discharged into the sewer in a safe and environmentally friendly manner.

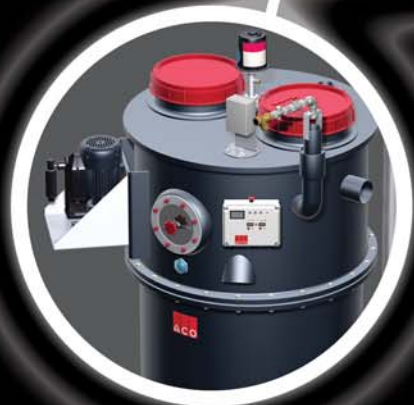
The Product:

The ACO Hydrojet grease separator constructed from corrosion resistant HDPE to easily discharge separated water into the sewer system

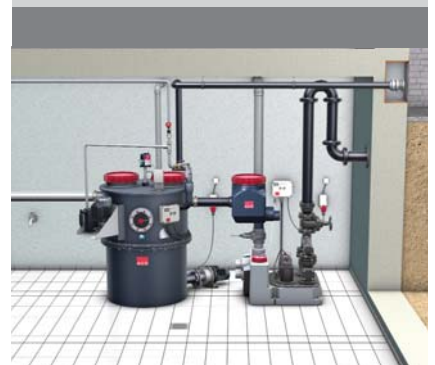
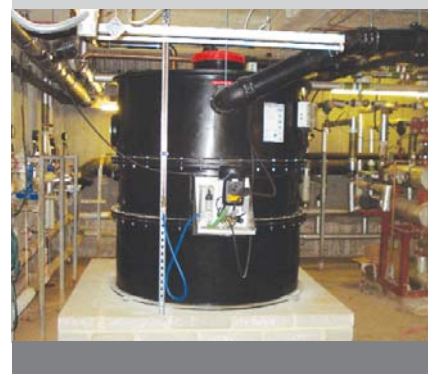
- Hammersmith Hospital kitchen used for the preparation of thousands of meals for the patients and staff on a daily basis
- Grease management system delivered within five weeks ensuring minimal disruption
- Hydrojet grease separator installed in hospital basement and dismantled into three components to enable efficient installation in restricted space and to allow waste collection by tanker at street level
- Hydrojet grease separator constructed from HDPE to eliminate smells and leakages
- New system used natural buoyancy process to separate FOGS from wastewater which is then discharged into the sewer system
